City of Santa Barbara California

PLANNING COMMISSION STAFF REPORT

REPORT DATE: November 22, 2011
AGENDA DATE: December 1, 2011
PROJECT ADDRESS: 1100, 1201 and 1335 Shoreline Drive (MST# 2009-00495)
 Shoreline Park Safety Improvement Project
TO: Planning Commission
FROM: Planning Division, (805) 564-5470
 Danny Kato, Senior Planner *D/K*
 Jan Hubbell, AICP, Parks Project Manager *JH*

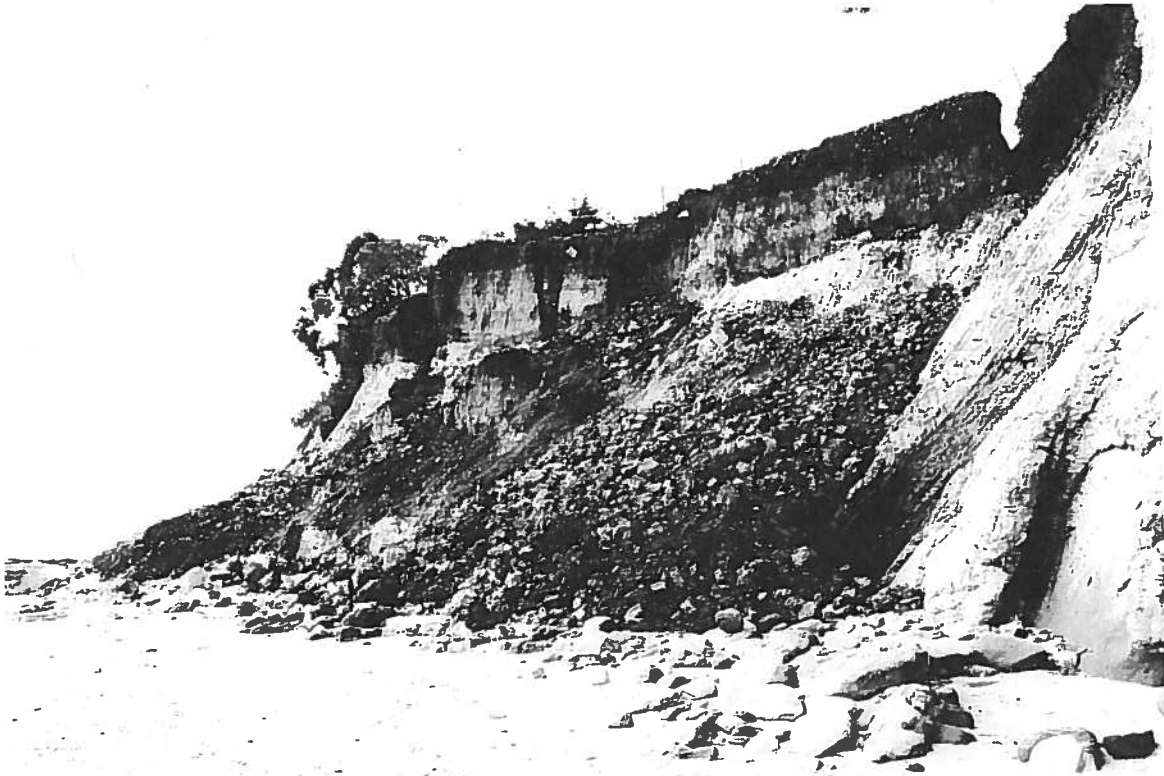
Photo 1 The active 2008 landslide viewed from the toe. 2/3/08

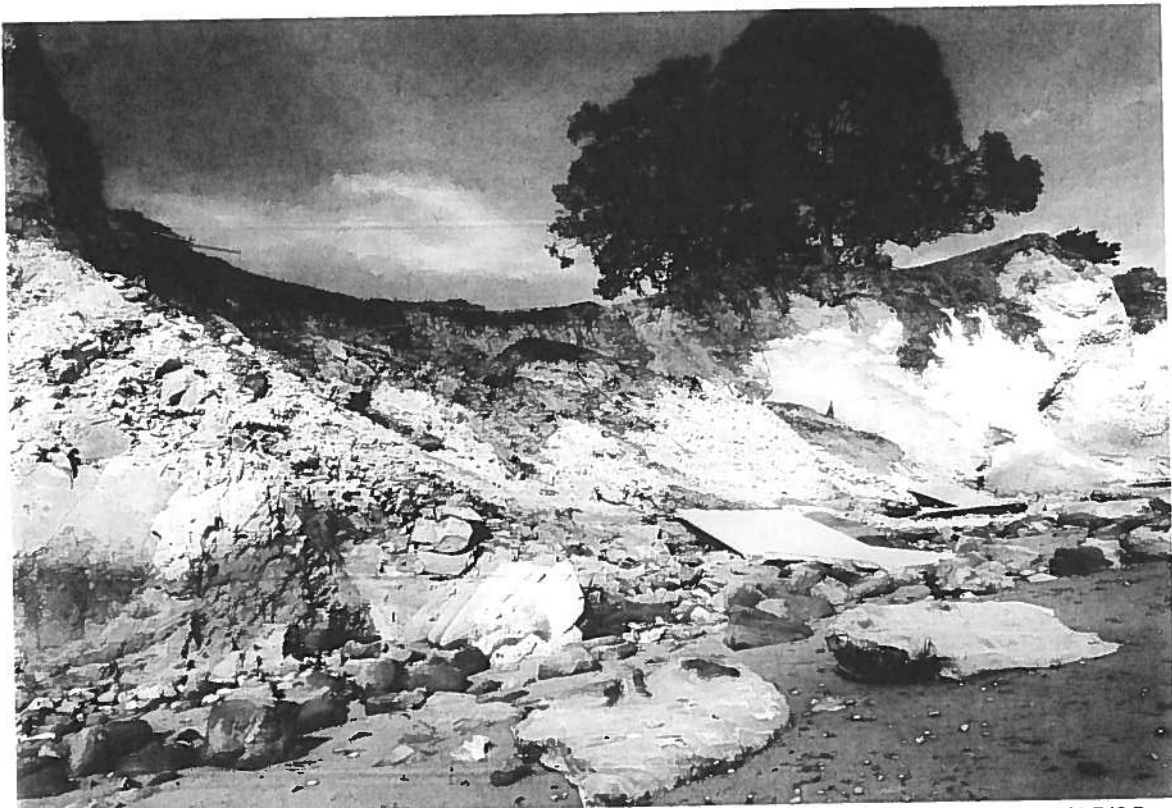
Photo 2 Continued movement and erosion of the 2008 active landslide. 10/15/08

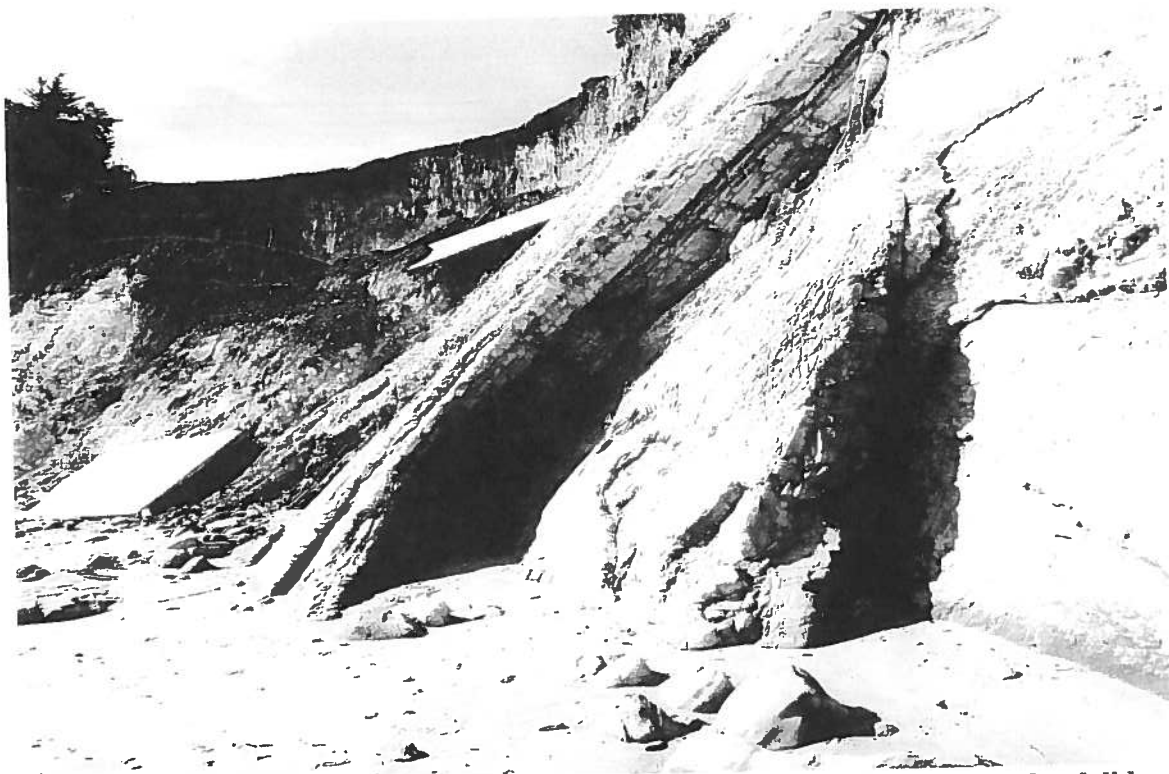
Photo 3 Differential erosion of weaker beds adjacent to east flank of the landslide.
10/15/08

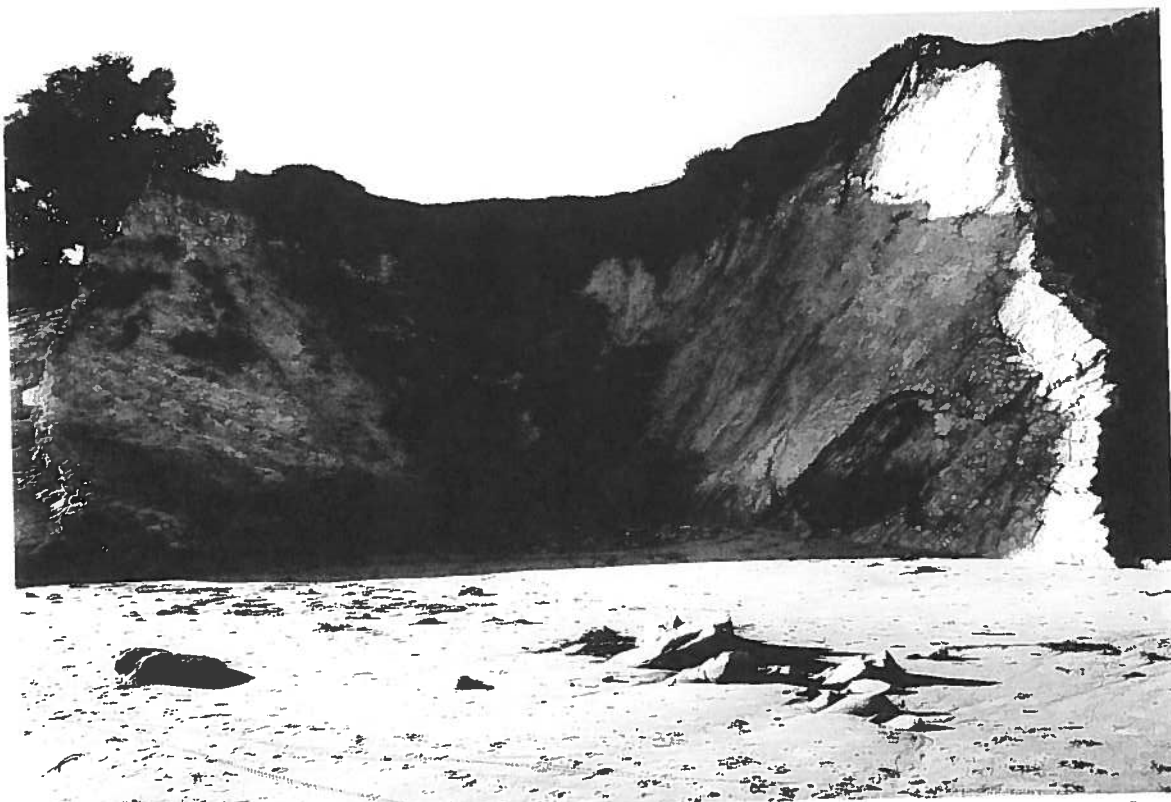
Photo 4 Sea cliff west of shoreline steps where an earlier landslide occurred and slide material has been eroded. 10/16/08

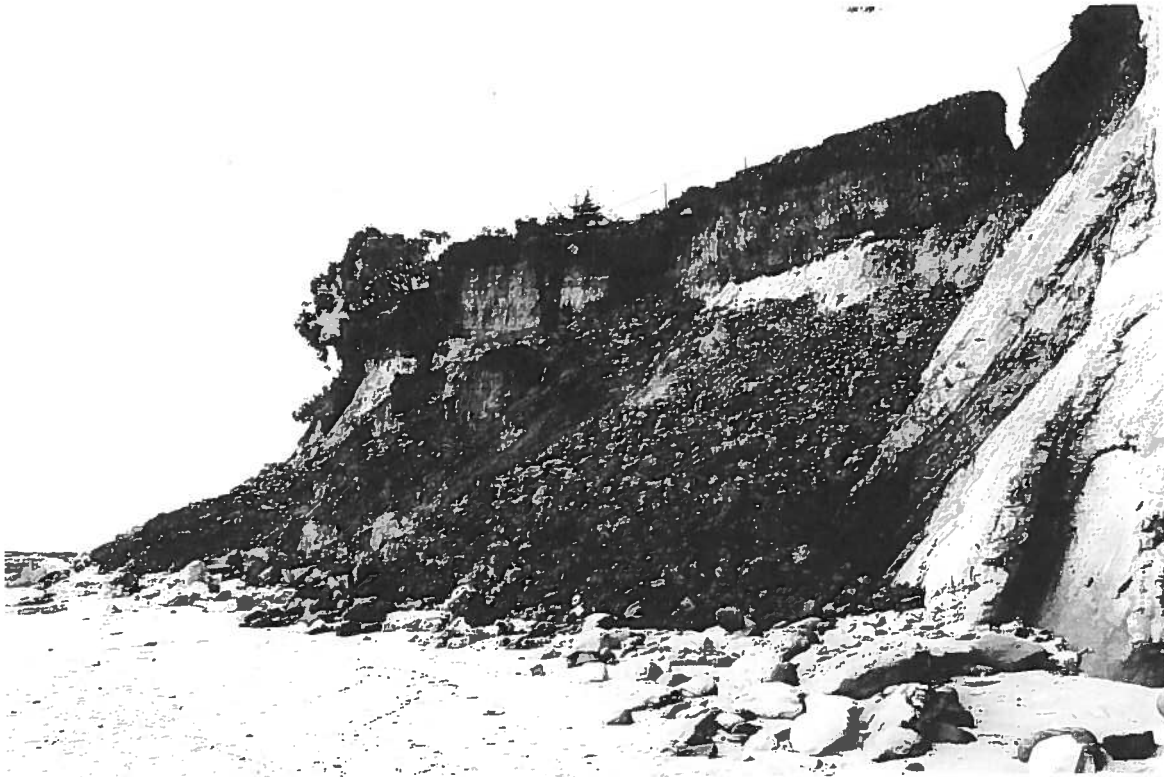
Photo 1 The 2008 active landslide looking west. 2/3/08

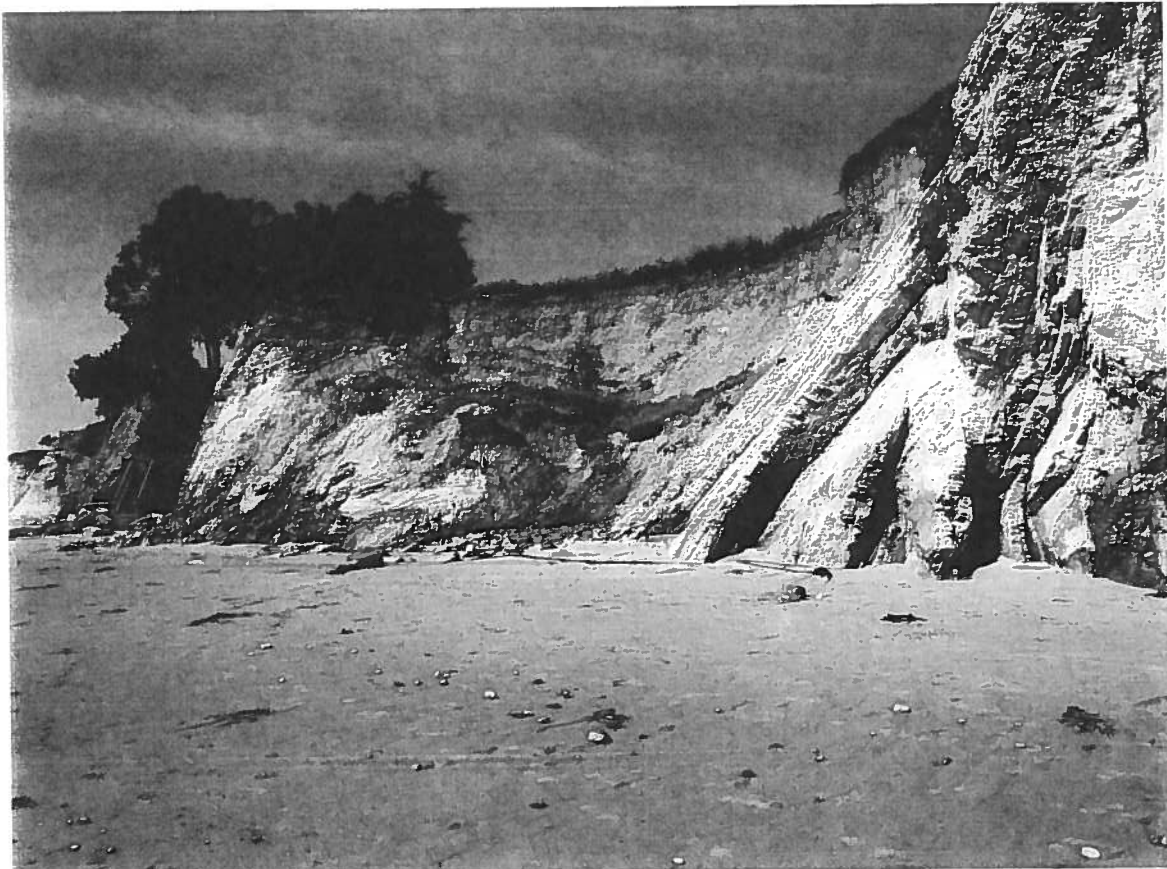
Photo 2 The 2008 active landslide approximately three years later. 3/15/11

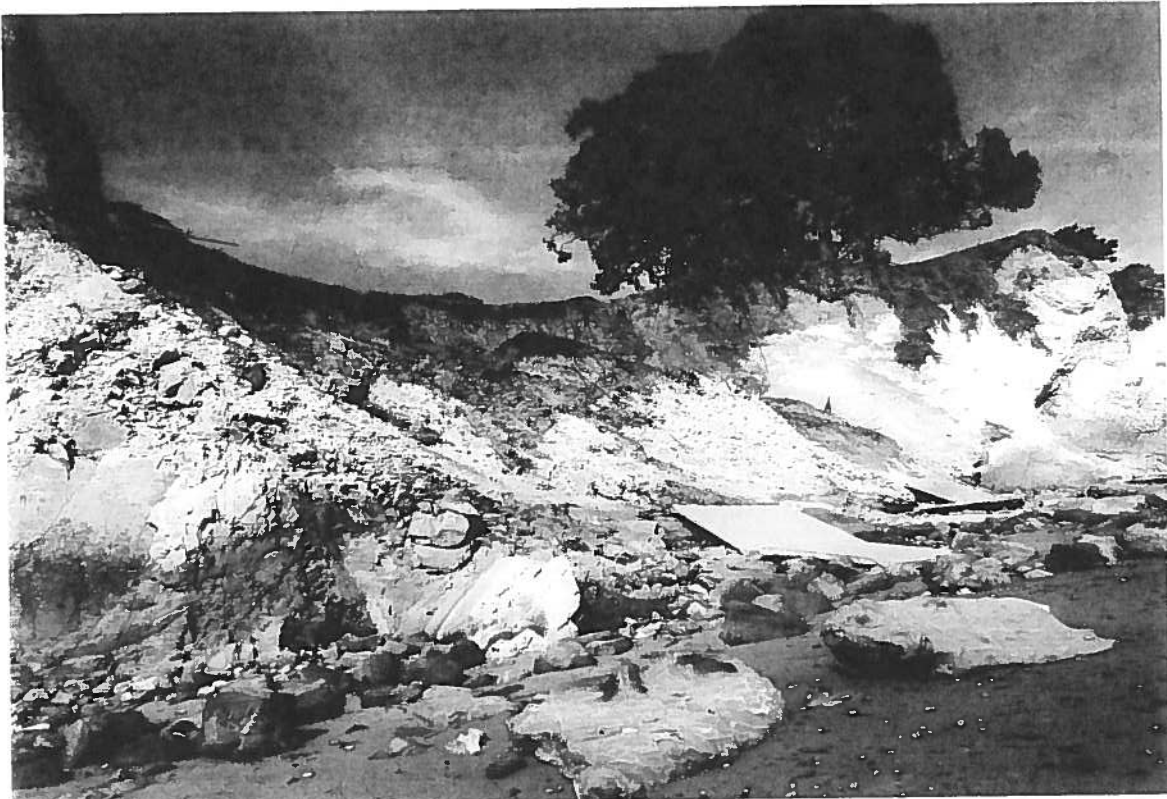
Photo 3 The 2008 active landslide looking east. 10/15/08

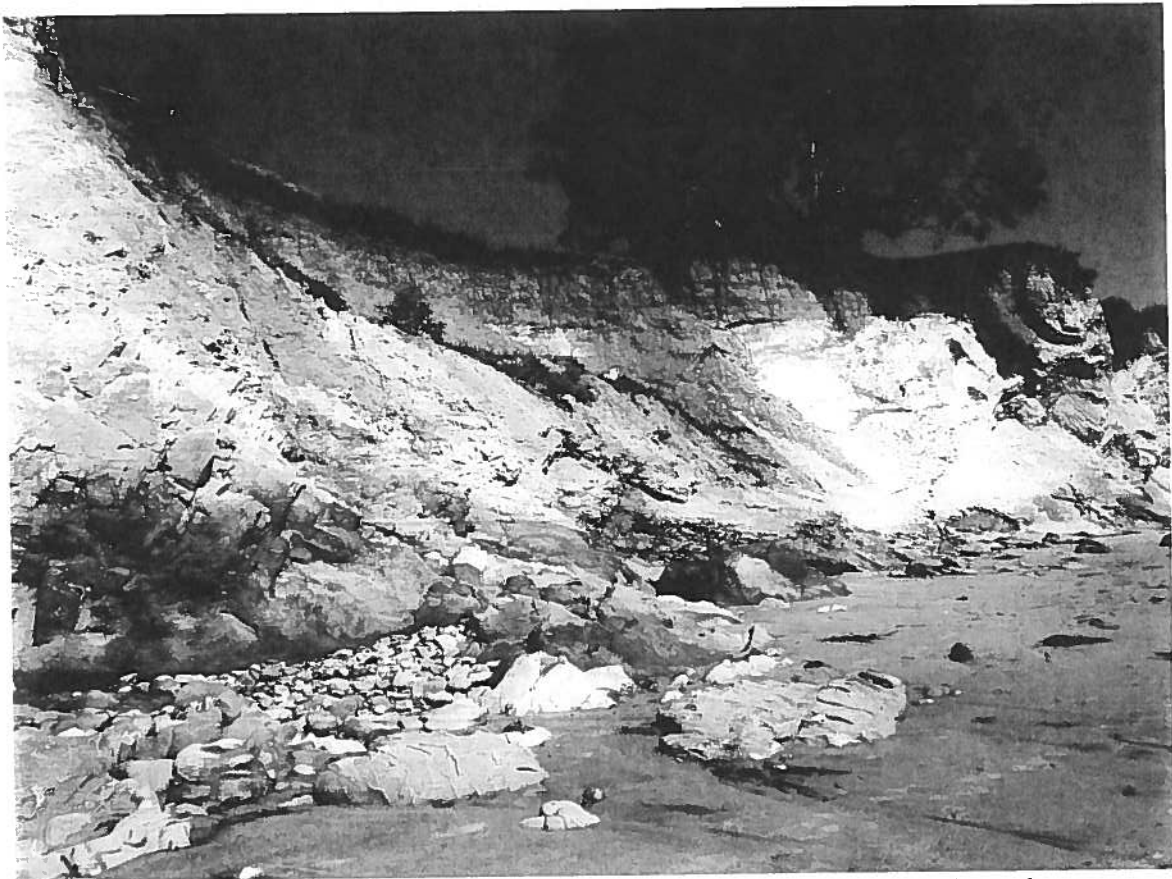
Photo 4 The 2008 active landslide looking east. Note slippage and erosion differences. 3/15/11

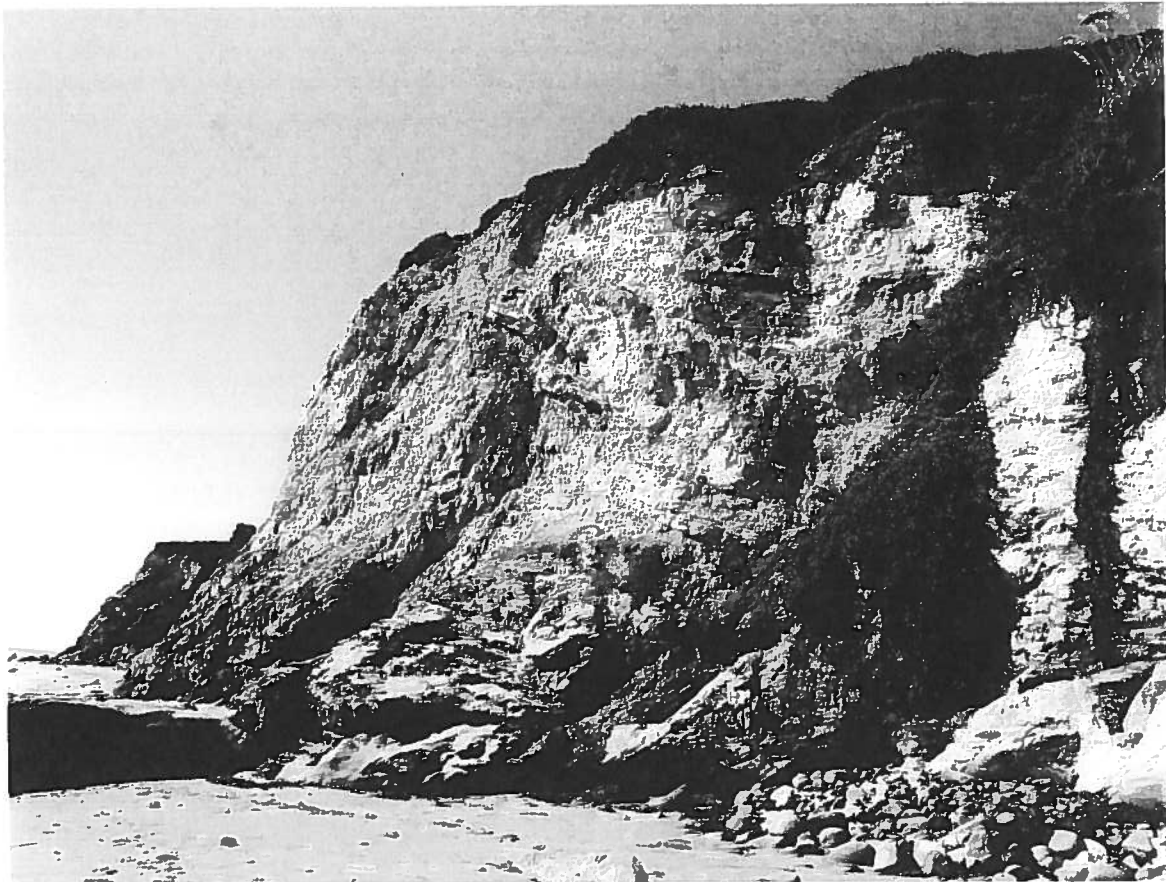
Photo 1 East side of slope descending from MacGillivray Point. 10/16//08

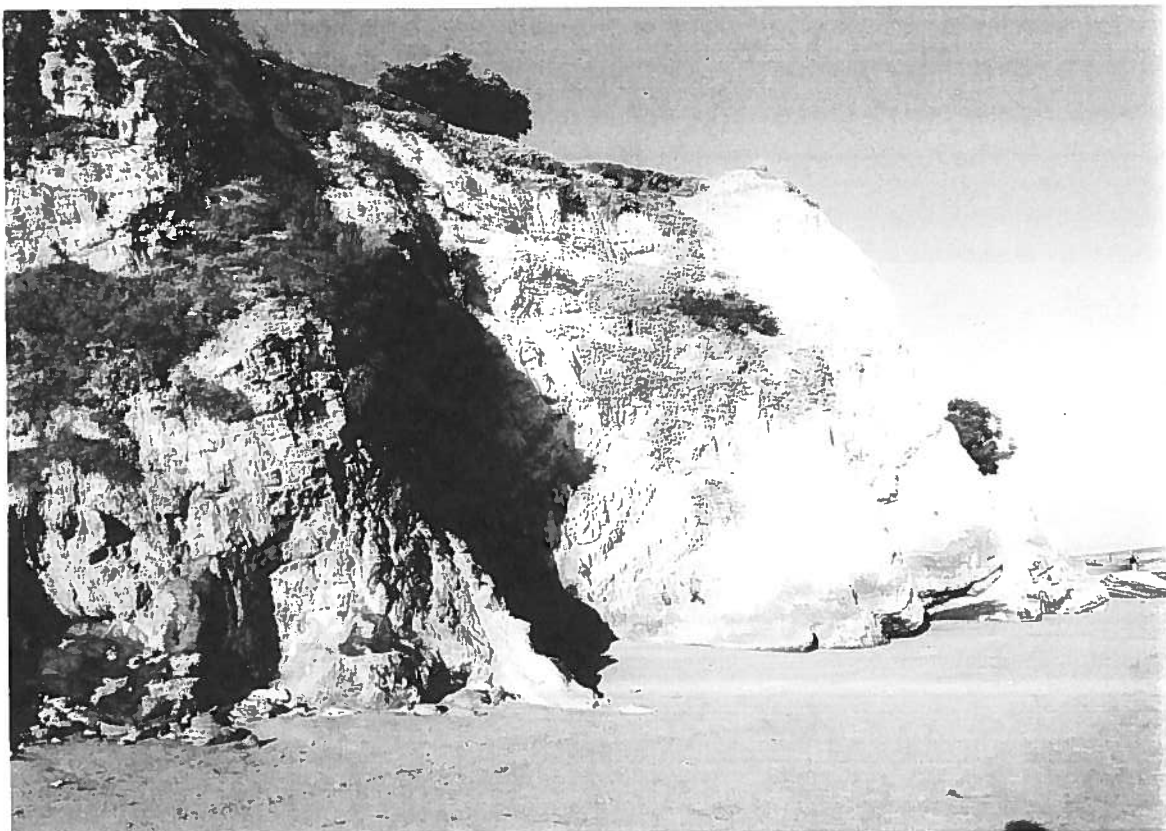
Photo 2 West side of slope descending from MacGillivray Point. 10/25/08

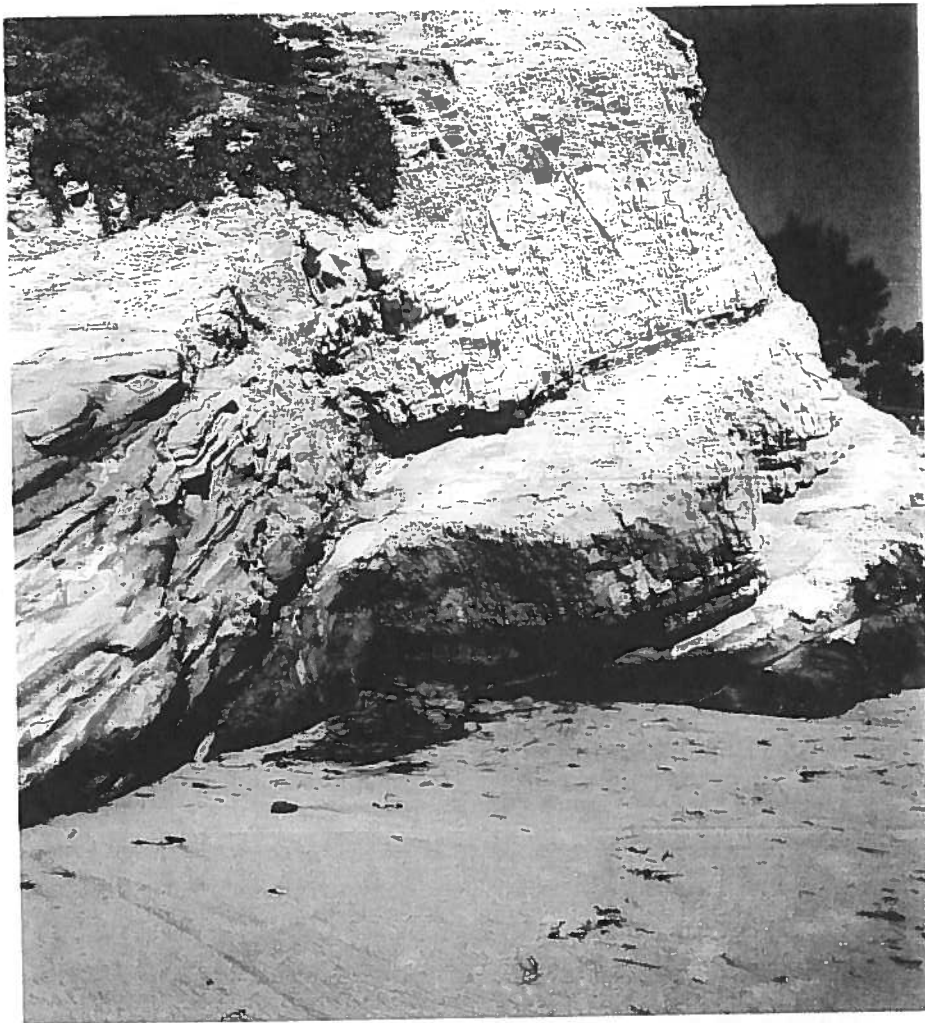
Photo 3
 Close up view of Photo 2
 soft clay beds are
 influencing slope erosion
 in this area. 10/16/08

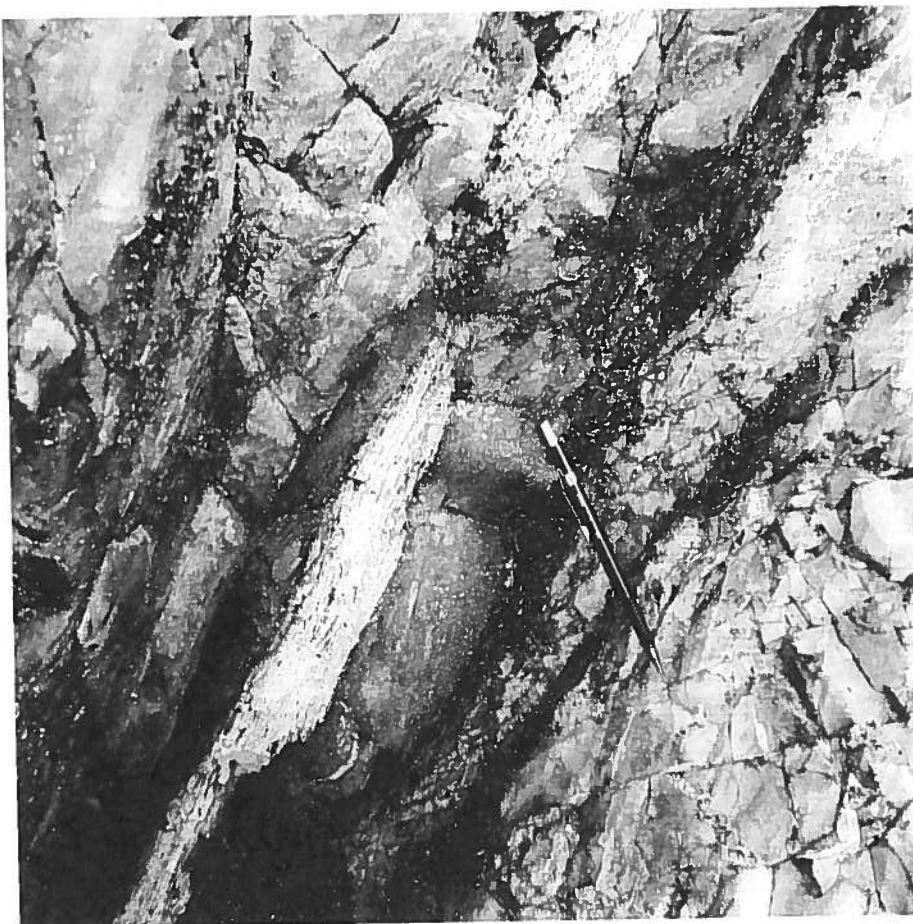
Photo 4
 Close up view of clay
 beds in the Monterey
 Formation. 10/15/08

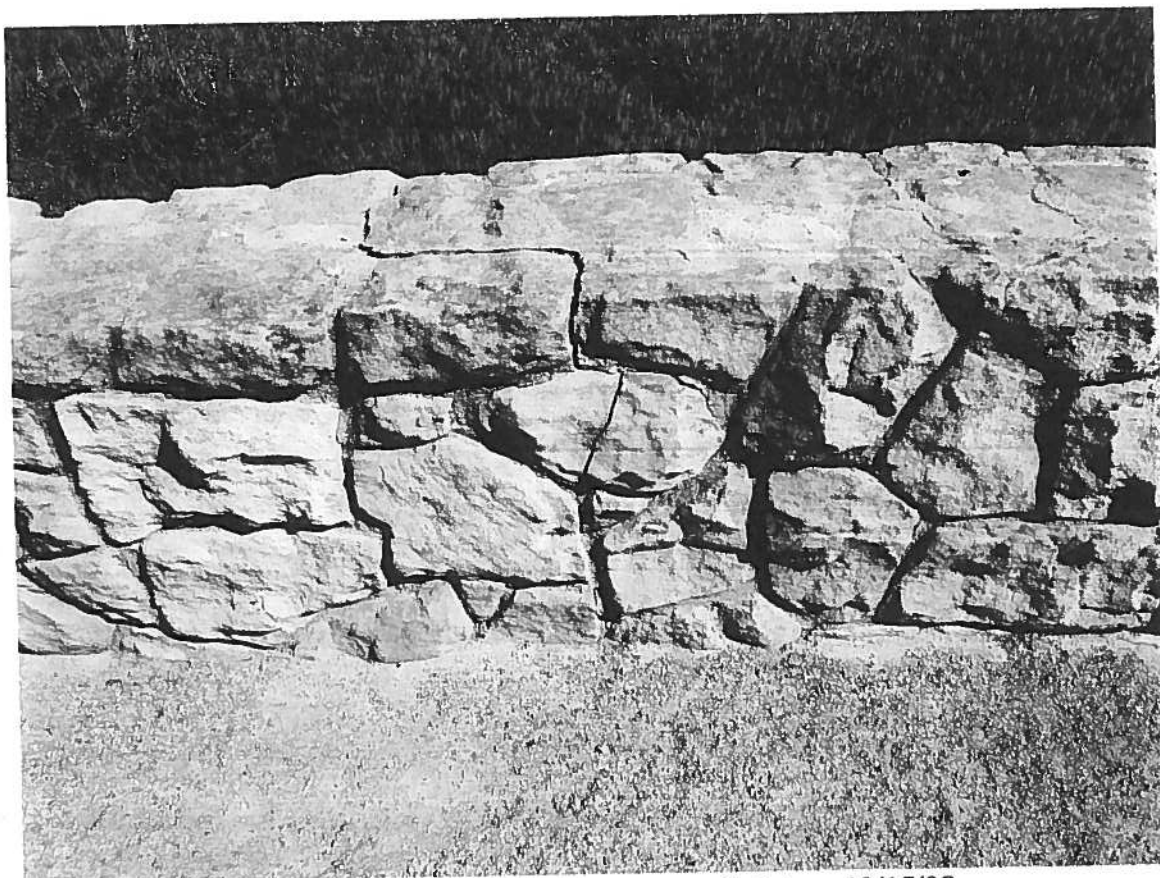
- The coastal bluff around the point has slowly eroded over time, leaving little remaining bluff at the edge of the lookout.
- Cracks in the low stone walls are likely to correspond to the location of a future landslide.
- Since a landslide in this area is likely to be sudden, a number of management options were recommended by the Geologist and were considered by the Parks and Recreation Department. These included: 1) closing the lookout indefinitely and installing a permanent chain link fence; 2) demolishing the look out and rebuilding a wall to commemorate Mayor MacGillivray; or 3) closing the lookout and monitoring the cracks to determine whether there is any change over time.
- Additional actions could include relocating the fence and sidewalk to the Probable Future Top of Slope, which is 17 to 23 feet from the existing top of slope, and monitoring movement at the point.

Photo 5 Crack in the stone wall at MacGillivray Point. 10/15/08

The Parks and Recreation Department is proposing a combination of options two and three above. The fence will be installed permanently, but there will also be ongoing monitoring. The fence at MacGillivray Point will be located at the Probable Future Top of Slope. As discussed above, bluff movement at MacGillivray Point is being monitored by the City Survey Crew. Several survey points have been established at the Point to determine movement. Initial surveys were carried out every two weeks; when no movement was found, surveys were changed to monthly checks; now, surveys are conducted quarterly. Over the past six to eight months, most survey points have shown no movement. There has been very minor movement at one of the points, amount to no more than 0.01 inches.

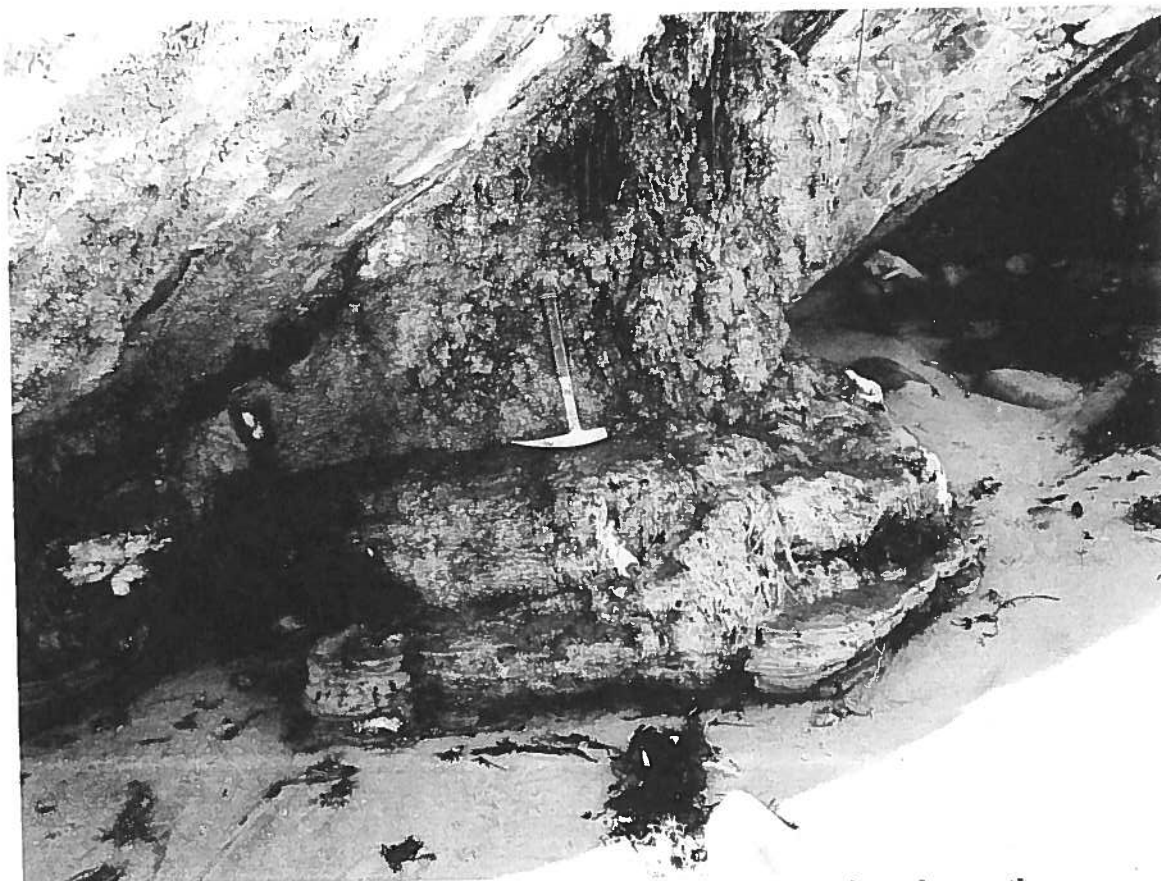
Photo 6 Seep near the sea cave entrance with evaporate mineral growth. 10/16/08
